Due by March 31, 2012

SECTION I. Municipal Information

Name of Municipality TOWN OF BROOKFIELD		Facility ID No. (FIN) 30730	
Mailing Address 645 N JANACECK RD	City BROOKFIELD	State WI	Postal Code 53045
County(s) in which Municipality is located WAUKESHA	Type of Municipality: (check one) <input type="checkbox"/> County <input type="checkbox"/> City <input type="checkbox"/> Village <input checked="" type="checkbox"/> Town <input type="checkbox"/> Other (specify)

The purpose of this Annual Report is to provide the status of the Town of Brookfield’s (Town’s) storm water management program. This report is prepared in compliance with the conditions of the NR 216 permit pursuant to Part II, Section I, of Wisconsin Pollutant Discharge Elimination System (WPDES) Permit Issuance No. WI-S050105-2. The contents of the report for calendar year 2011 include information as requested in Part II.I of the permit.

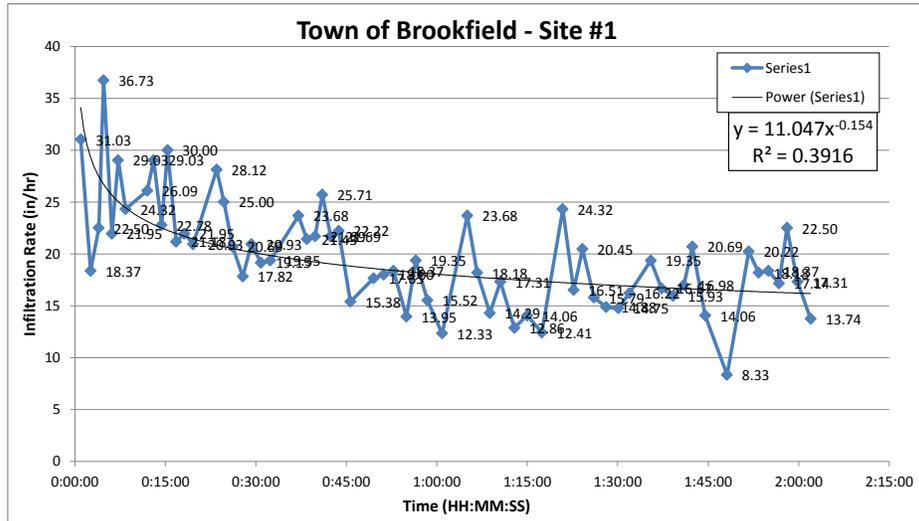
Location	Site # 1: Jill Ct and Sierra Dr, Town of Brookfield
Date:	4/14/2011
Time:	8:41 AM to 10:43 AM
Conditions (Temp., etc.):	Cold, Cloudy, Sprinkles
Field Staff:	SSS
Most Recent Rainfall Event (Date/Amount):	4/14/11 - Trace
Equipment Used:	Double Ring Infiltrometer
Gallons Used During Test (12-Inch Ring):	15.42

The field infiltration test results were graphed to show the infiltration rate, measured in inches per hour, over the time elapsed. The tables and graphs for each test location are attached for you use and review. A "best fit curve" was then applied to the graphed data. Using the "best fit curve" equation, the infiltration rate was calculated for the end of a two hour test.

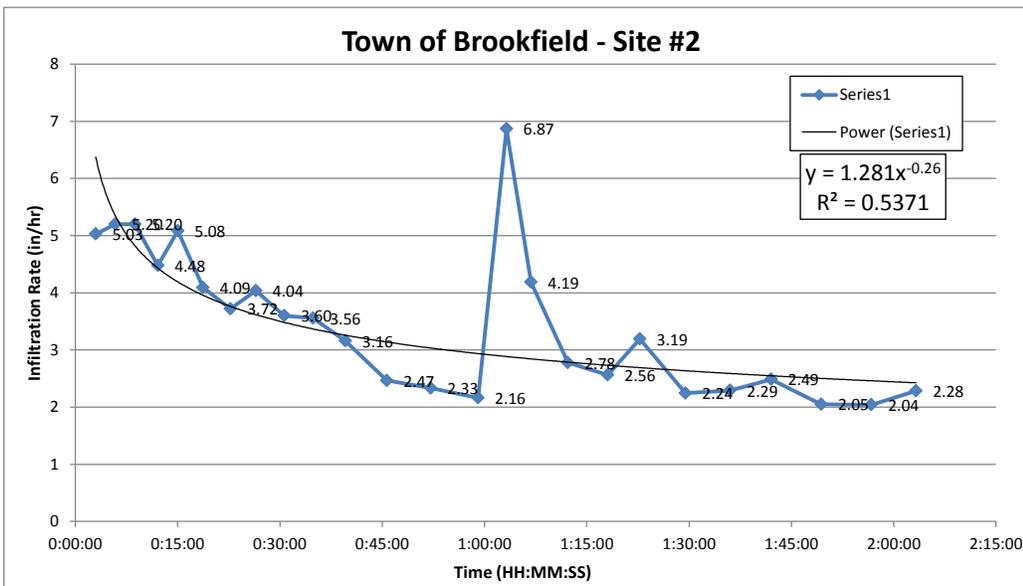
Static Infiltration Rate
After 2 Hours
2.44 in/hr

Location	Site #2: Brenner Ct and Brenner Dr, Town of Brookfield
Date:	4/13/2011
Time:	3:55 PM to 5:58 PM
Conditions (Temp., etc.):	Clear, 60 degrees
Field Staff:	Small
Most Recent Rainfall Event (Date/Amount):	4/10/2011
Equipment Used:	Double Ring Infiltrometer
Gallons Used During Test (12-Inch Ring):	3.06

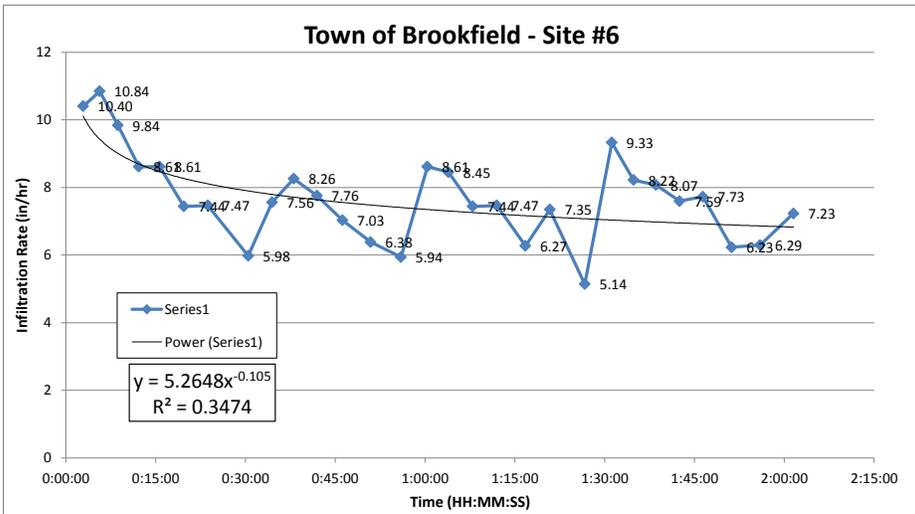
Static Infiltration Rate
After 2 Hours
6.83 in/hr

Location	Site #6: Bowling Green Rd and Catskill Rd, Town of Brookfield
Date:	4/21/2011
Time:	1:36 PM to 3:37
Conditions (Temp., etc.):	Partly Cloudy
Field Staff:	Small
Most Recent Rainfall Event (Date/Amount):	4/20/11 (trace), more on 4/19/11
Equipment Used:	Double Ring Infiltrometer
Gallons Used During Test (12-Inch Ring):	7.10

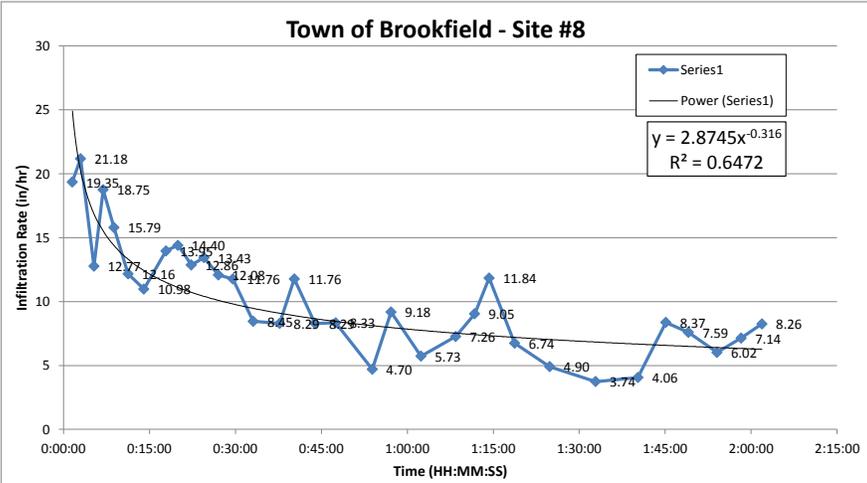
Location	Site #8: Plateau Rd and Doneswood Dr, Town of Brookfield
Date:	4/14/2011
Time:	12:16 PM TO 4:17 PM
Conditions (Temp., etc.):	Cold, Sprinkles
Field Staff:	Small
Most Recent Rainfall Event (Date/Amount):	4/10/2011
Equipment Used:	Double Ring Infiltrometer
Gallons Used During Test (12-Inch Ring):	8.07

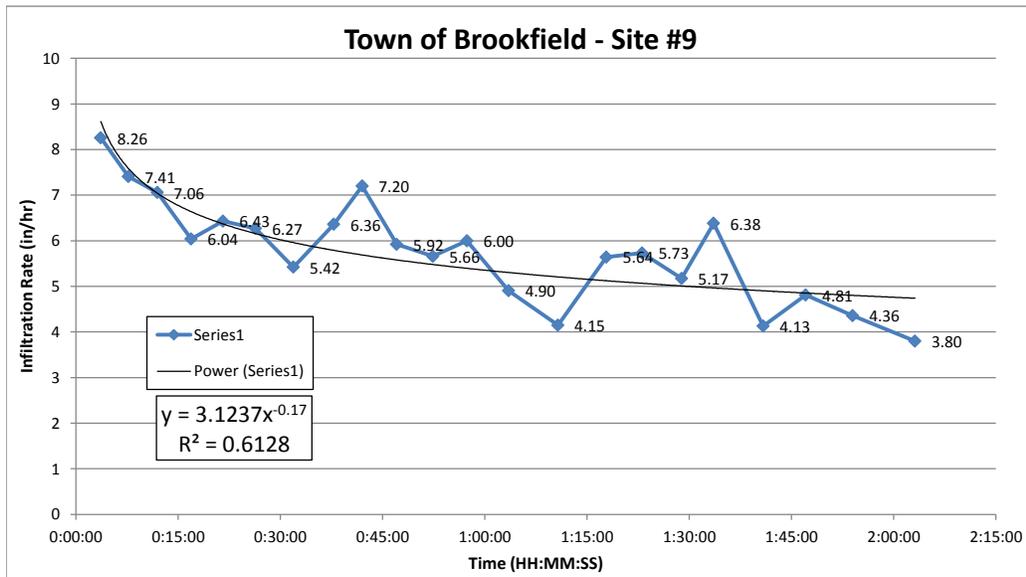
Static Infiltration Rate
After 2 Hours
4.77 in/hr

Location	Site #9: E Ravenswood Dr (Midway), Town of Brookfield
Date	4/21/2011
Time	3:57:00 PM to 6:00 PM
Conditions (Temp., etc.):	Cloudy
Field Staff:	Small
Most Recent Rainfall Event (Date/Amount):	4/20/2011
Equipment Used:	Double Ring Infiltrometer
Gallons Used During Test (12-Inch Ring):	5.38

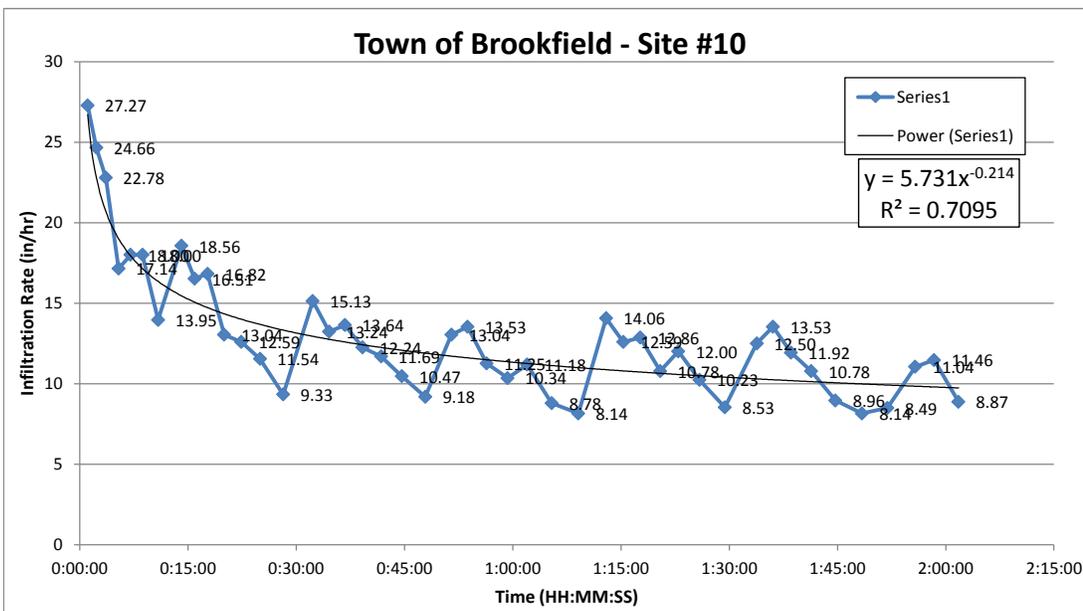
Location	Site #10: Poplar Creek Dr and Linden Ln, Town of Brookfield
Date	4/21/2011
Time	6:09 PM to 8:10 PM
Conditions (Temp., etc.)	Cloudy, Cool
Field Staff	Small
Most Recent Rainfall Event (Date/Amount)	Trace 4/20/11 more on 4/19/11
Equipment Used	Double Ring Infiltrometer
Gallons Used During Test (12-Inch Ring)	11.01

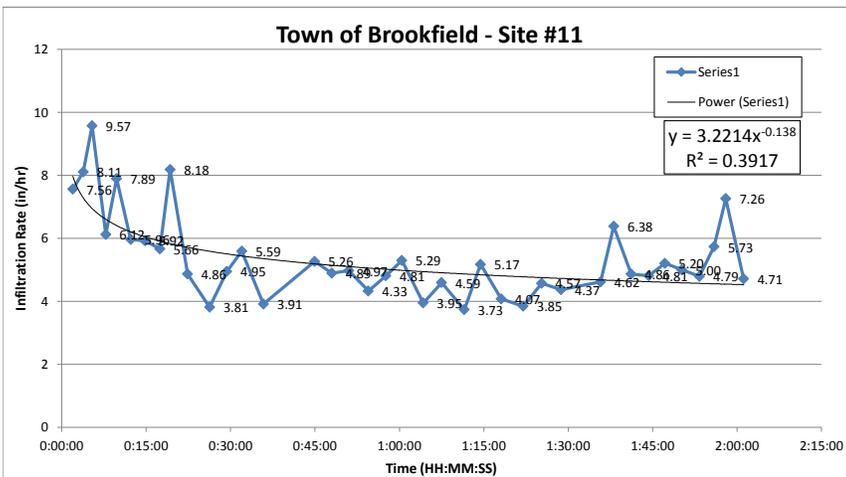
Static Infiltration Rate After 2 Hours
4.54 in/hr

Location	Site #11: Mayrose Blvd and De Carlin Dr, Town of Brookfield
Date	4/20/2011
Time	8:53 AM to 10:54 AM
Conditions (Temp., etc.)	Cloudy, Mist
Field Staff	Small
Most Recent Rainfall Event (Date/Amount)	4/19/2011
Equipment Used	Double Ring Infiltrometer
Gallons Used During Test (12-Inch Ring)	4.65

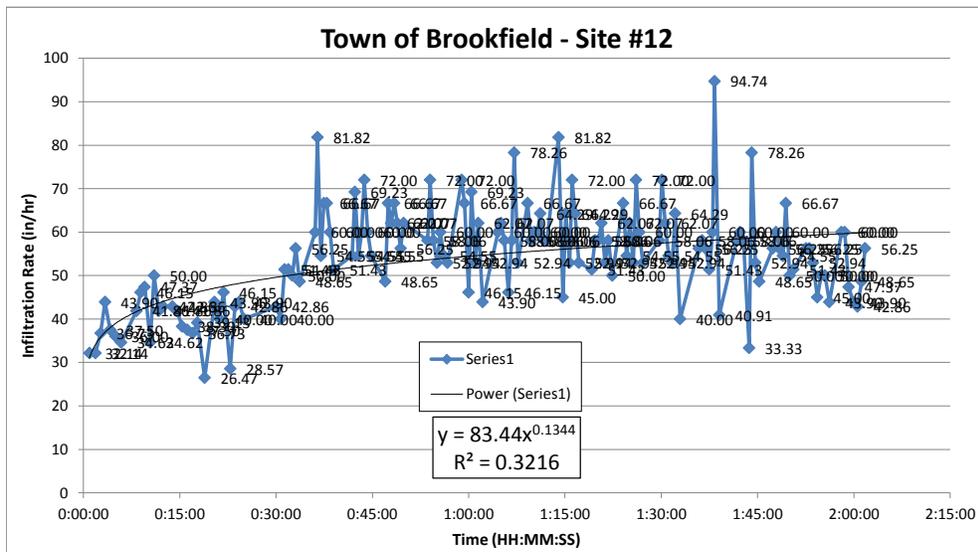
Static Infiltration Rate
After 2 Hours
59.75 in/hr

Location	Site #12: Martha Ln (Midway), Town of Brookfield
Date:	4/14/2011
Time:	8:41 AM to 10:42 AM
Conditions (Temp., etc.):	old, Cloudy, Sprinkles
Field Staff:	Small
Most Recent Rainfall Event (Date/Amount):	4/14/11 Trace
Equipment Used:	Double Ring Infiltrometer
Gallons Used During Test (12-Inch Ring):	35.97
